Senna Hills Municipal Utility District General Managers Report for the Month of January 2021

Board Meeting: February 26th, 2021

Subject: General Manager's Executive Summary Report

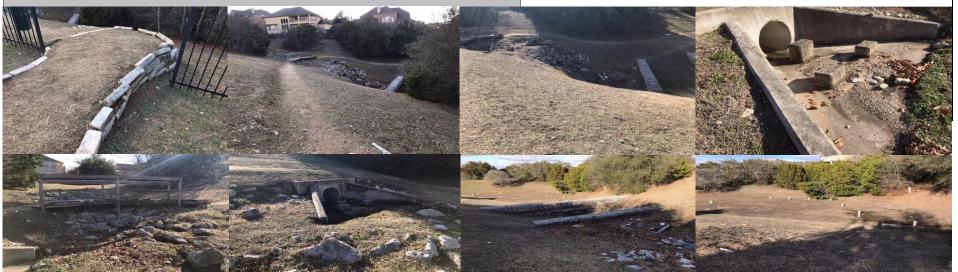
BRICKS AT ENTRANCE NEED TO BE RELAYED, BRIDGE NEEDS ATTENTION, FENCE IS DAMAGED

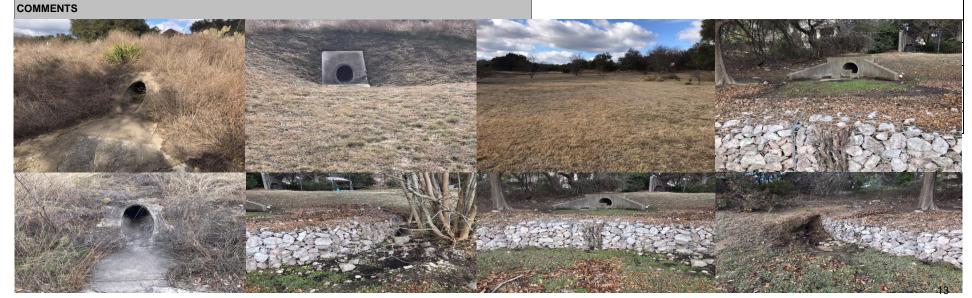
Pond Location	SEC 4
Pond water level	DRY
Does the pond drain within 48 hours?	YES
Sediment depth in the forbay?	N/A
Sediment depth in the sand filter area?	N/A
Trash found at site?	SOME
Is vegetation below 18" in height?	NO
Trees or brush found in basin area?	NO
Condition of the media?	GOOD
Condition of vegetation around the out fall pipe	GOOD
Was sediment found in the under drain piping? Remove open clean out tops and check	NO
Any damage to structural elements (pipes, concrete drainage, retaining walls, gabian walls, etc.)?	EROSION ISSUE NEXT TO EMBANKMENT AT GABION - WO 2443736
Discharge valve open operational	N/A
Emergency bypass valve closed and operational	N/A
Are all inlets in area clear of debris and sediment?	YES
	EROSION ISSUE NEXT TO EMBANKMENT AT GABION - WO 2443736

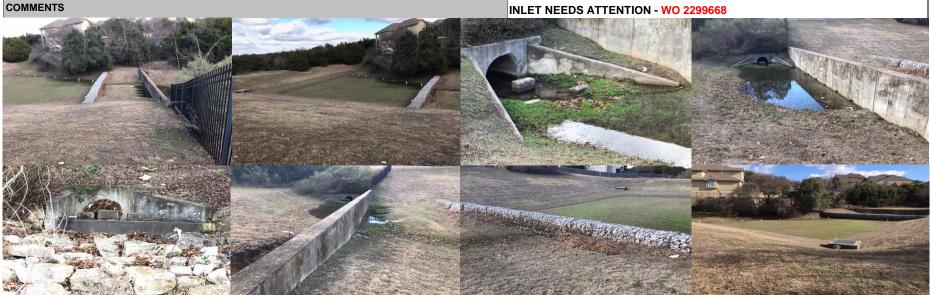
Pond Location	STRAWFLOWER
Pond water level	5%
Does the pond drain within 48 hours?	YES
Sediment depth in the forbay?	HAS DEEP SPOTS AT FORBAY
Sediment depth in the sand filter area?	3"
Trash found at site?	SOME
Is vegetation below 18" in height?	YES
Trees or brush found in basin area?	NO
Condition of the media?	GOOD
Condition of vegetation around the out fall pipe	GOOD
Was sediment found in the under drain piping? Remove open clean out tops and check	NO
Any damage to structural elements (pipes, concrete drainage, retaining walls, gabian walls, etc.)?	NO
Discharge valve open operational	N/A
Emergency bypass valve closed and operational	N/A
Are all inlets in area clear of debris and sediment?	NO - SEDIMENT & VEGETATION
