Senna Hills Municipal Utility District

Senna Hills Municipal Utility District
General Managers Report for the Month of
April 2021
Board Meeting: May 28th, 2021

Subject: General Manager's Executive Summary Report

SAMCO FINAL LEAK DETECTION REPORT

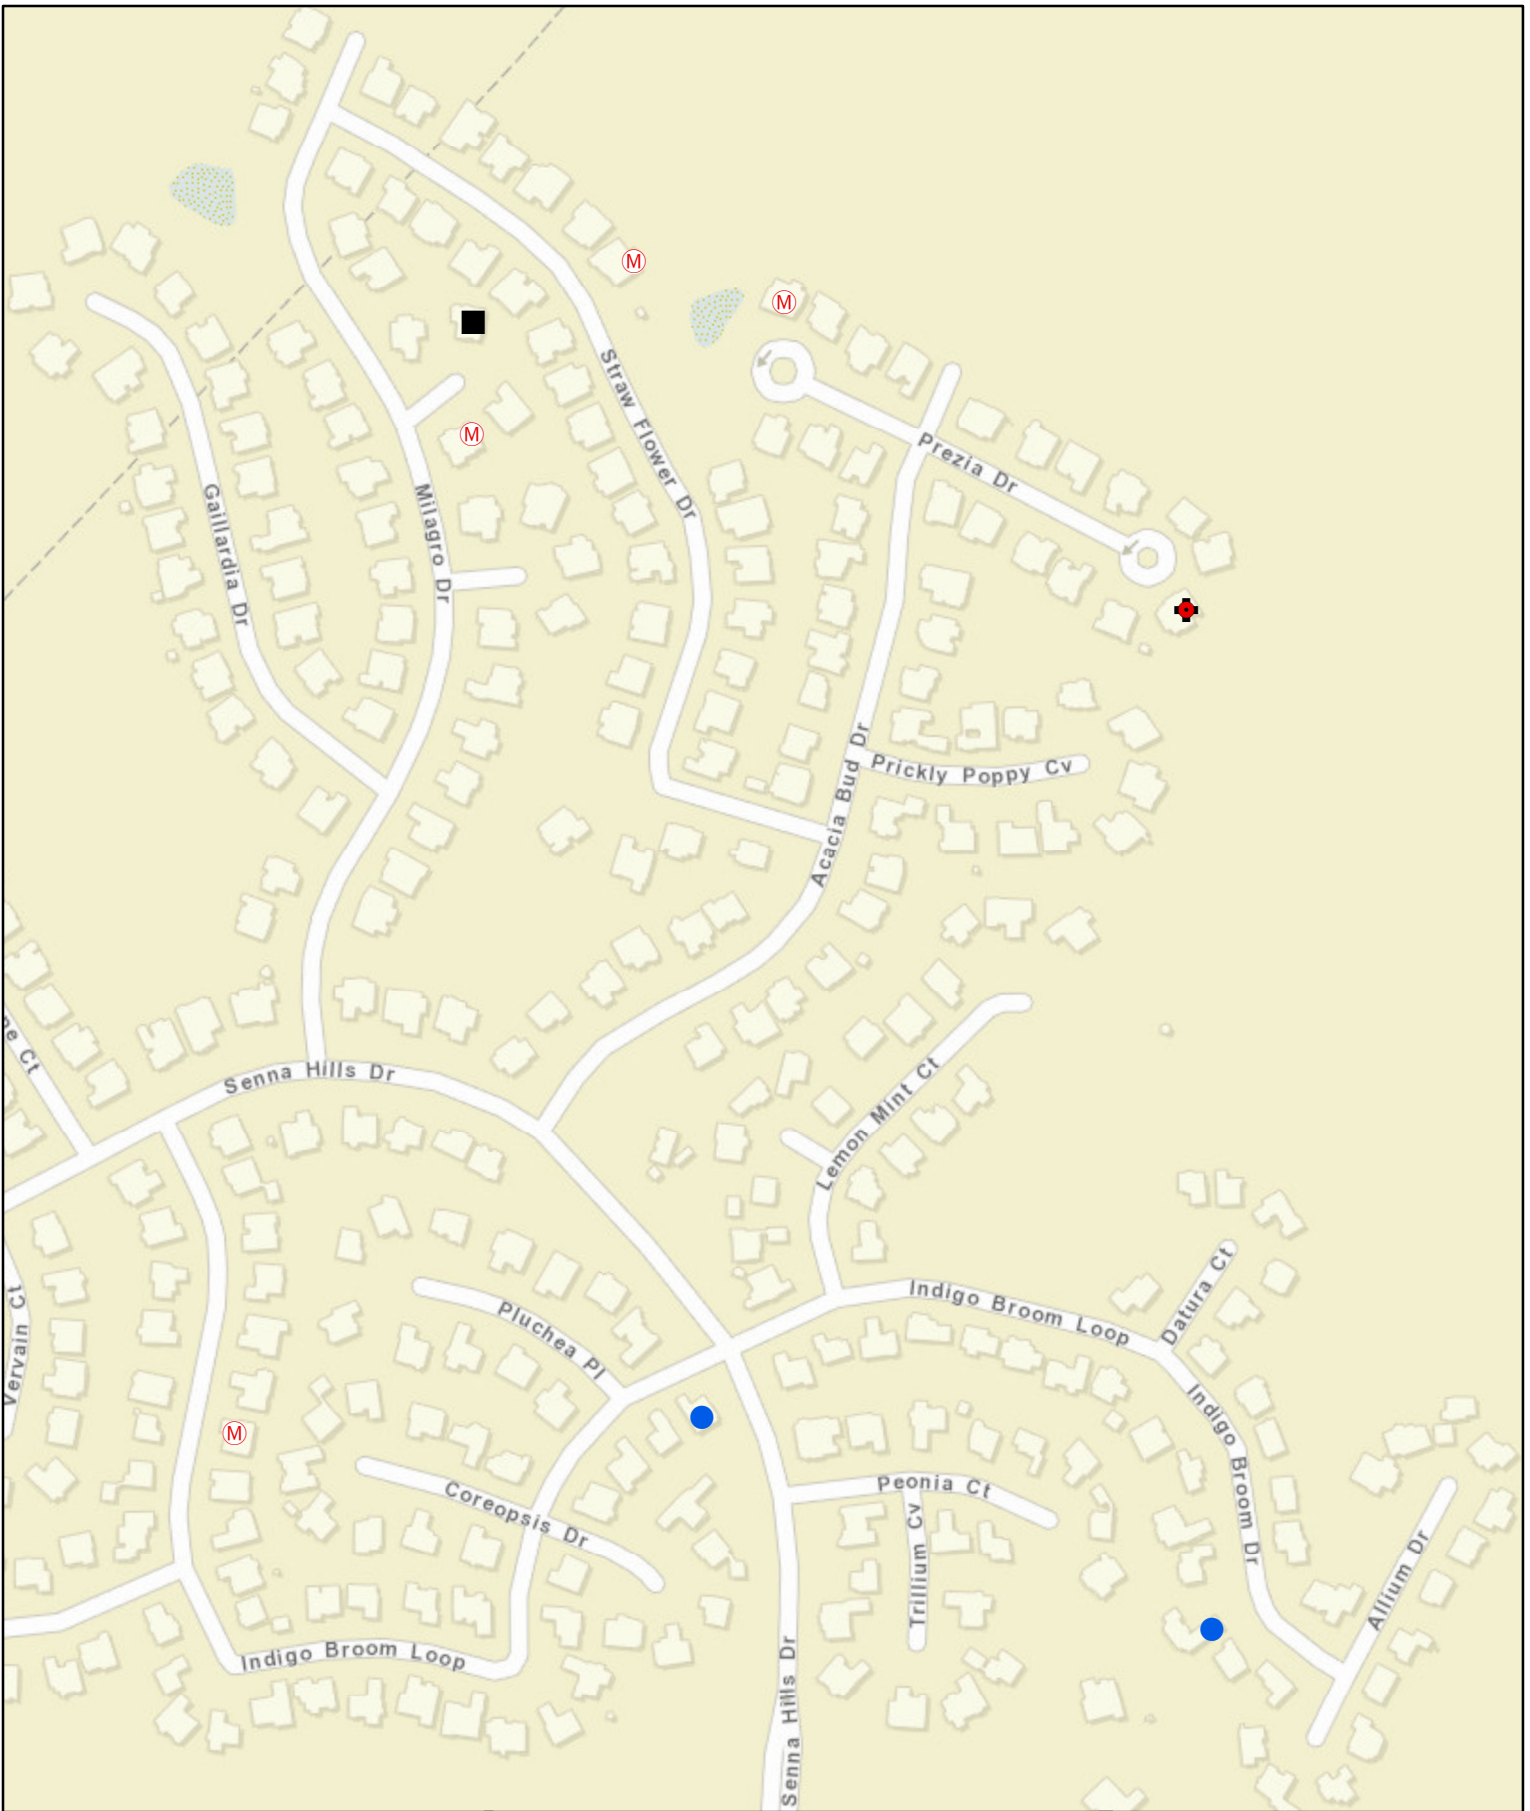
Leak Identification Map, 2021

During the project (8) leaks consisting of; (2) service line leaks, (1) one fire hydrant leak, (4) four meter box leaks, and (1) one customer side leak; were identified. The leak locations and descriptions are listed below. Please do not hesitate to contact Hunter Skelton at 512-809-3461 if you have any questions or need assistance with the location of the following leaks or water loss issues listed below. All items identified as critical are considered to be in need of immediate attention.

- Investigate and repair service side leaks
- Investigate and repair meter box leaks
- Investigate, flush, reseal and repair if necessary fire hydrant leaks
- Investigate and recommend customer repair customer side leak
- Continue leak detection to further investigate and reduce water loss

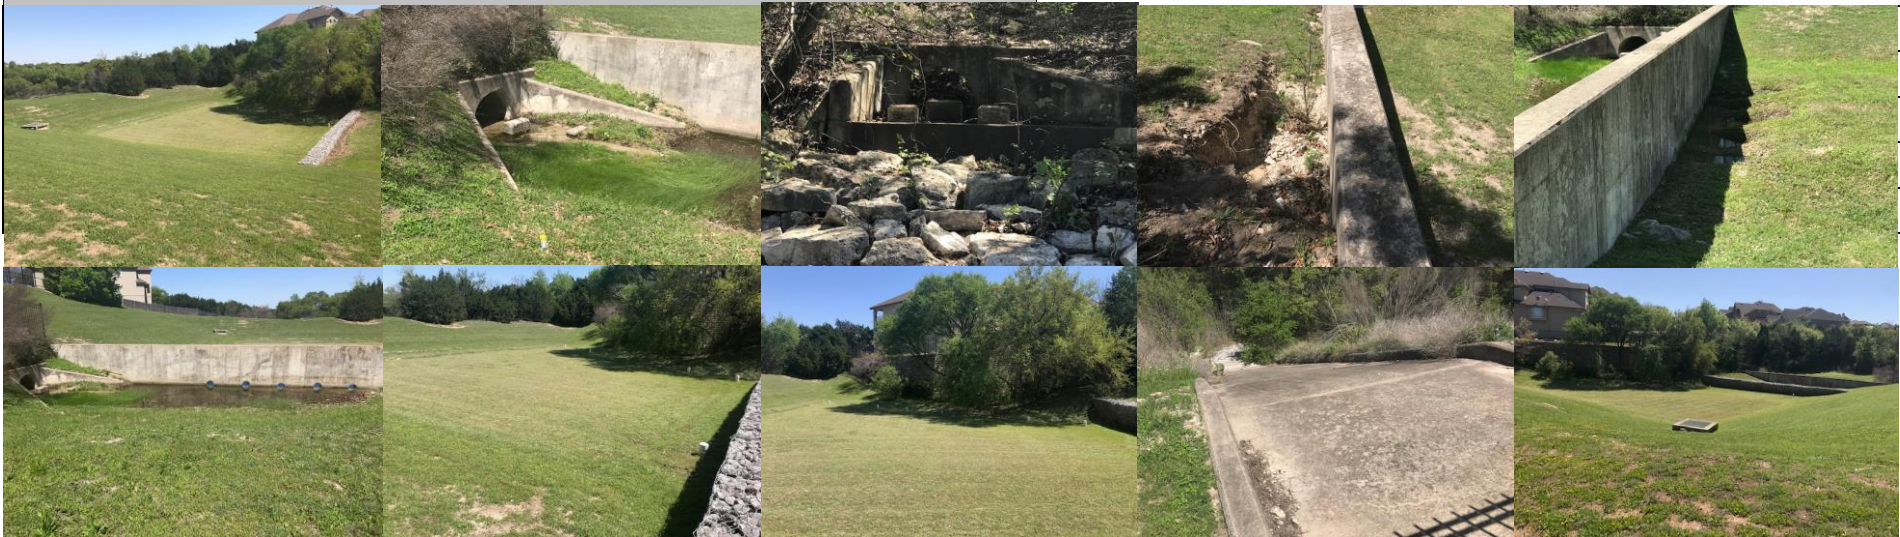
Pond Location	STRAWFLOWER
Pond water level	WET
Does the pond drain within 48 hours?	YES
Sediment depth in the forbay?	HAS DEEP SPOTS AT FORBAY
Sediment depth in the sand filter area?	WET
Trash found at site?	NO
Is vegetation below 18" in height?	YES
Trees or brush found in basin area?	NO
Condition of the media?	GOOD
Condition of vegetation around the out fall pipe	GOOD
Was sediment found in the under drain piping? Remove open clean out tops and check	NO
Any damage to structural elements (pipes, concrete drainage, retaining walls, gabian walls, etc.)?	NO
Discharge valve open operational	N/A
Emergency bypass valve closed and operational	N/A
Are all inlets in area clear of debris and sediment?	NO - SEDIMENT & VEGETATION

FALLEN TREE LEANING INTO SAND FILTER (OBTAIN QUOTE) - WO 2491778

COMMENTS **INLET NEEDS ATTENTION - WO 2299668**

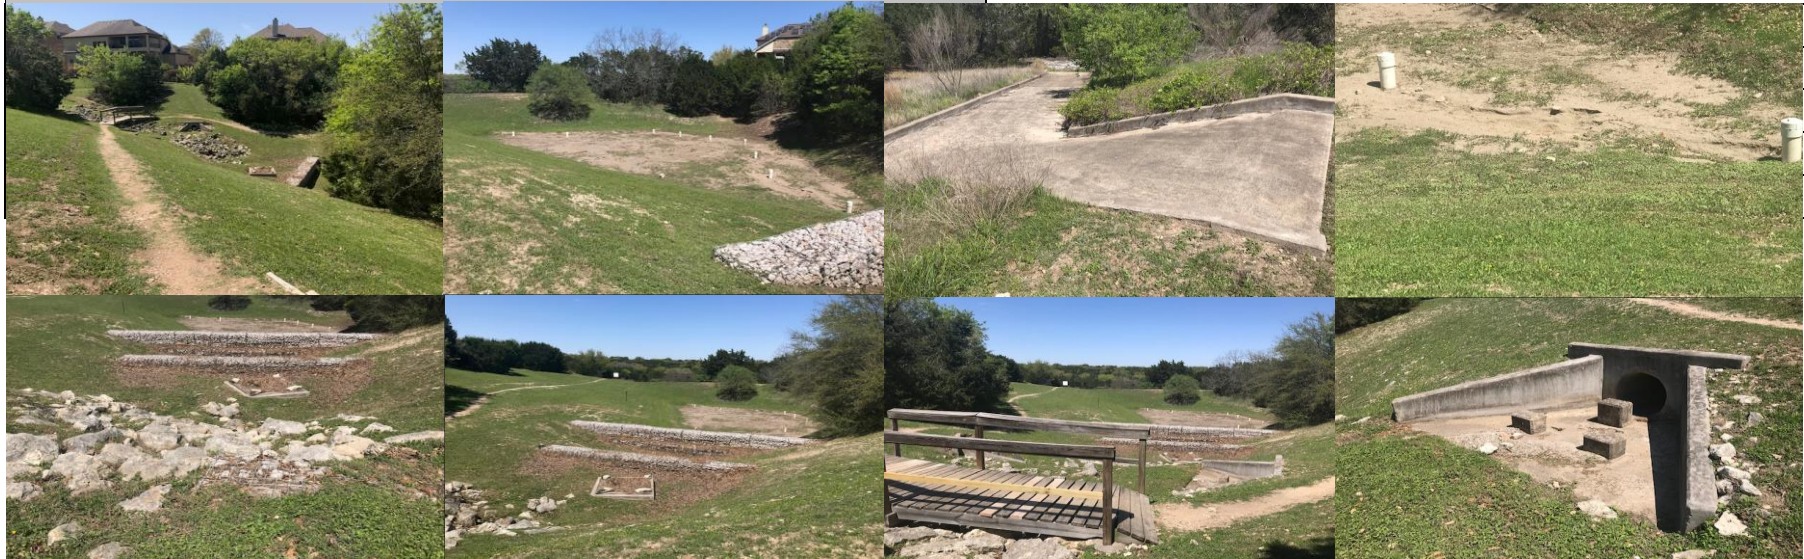
Pond Location	MILAGRO
Pond water level	DRY
Does the pond drain within 48 hours?	2" - 3"
Sediment depth in the forbay?	2" - 3"
Sediment depth in the sand filter area?	NO
Trash found at site?	NO
Is vegetation below 18" in height?	NO
Trees or brush found in basin area?	NO
Condition of the media?	LOTS OF DRY LEAVES
Condition of vegetation around the out fall pipe	GOOD
Was sediment found in the under drain piping? Remove open clean out tops and check	NO
Any damage to structural elements (pipes, concrete drainage, retaining walls, gabian walls, etc.)?	NO
Discharge valve open operational	N/A
Emergency bypass valve closed and operational	N/A
Are all inlets in area clear of debris and sediment?	YES

COMMENTS BRICKS AT ENTRANCE NEED TO BE RELAYED, BRIDGE NEEDS ATTENTION, FENCE IS DAMAGED

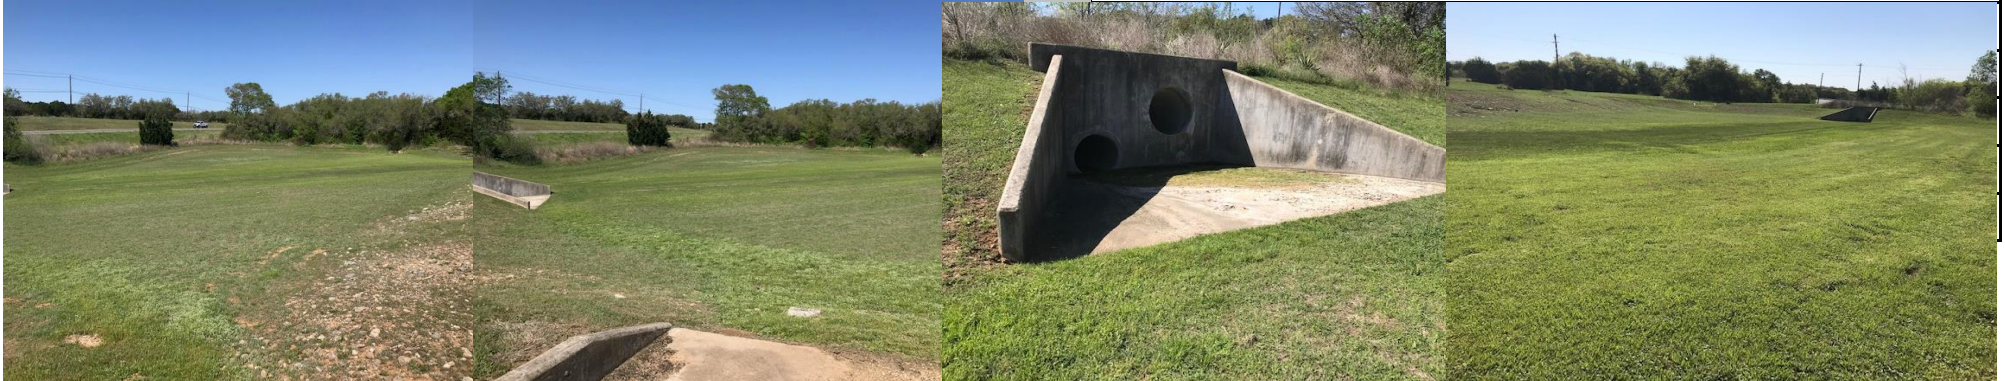
Pond Location	SEC 2
Pond water level	WET
Does the pond drain within 48 hours?	YES
Sediment depth in the forbay?	N/A
Sediment depth in the sand filter area?	N/A
Trash found at site?	NO
Is vegetation below 18" in height?	YES
Trees or brush found in basin area?	NO
Condition of the media?	GOOD
Condition of vegetation around the out fall pipe	NEEDS ATTENTION
Was sediment found in the under drain piping? Remove open clean out tops and check	N/A
Any damage to structural elements (pipes, concrete drainage, retaining walls, gabian walls, etc.)?	NO
Discharge valve open operational	N/A
Emergency bypass valve closed and operational	N/A
Are all inlets in area clear of debris and sediment?	YES
COMMENTS	CLEAN VEGETATION AROUND DOUT FALL PIPE - WO 2491804

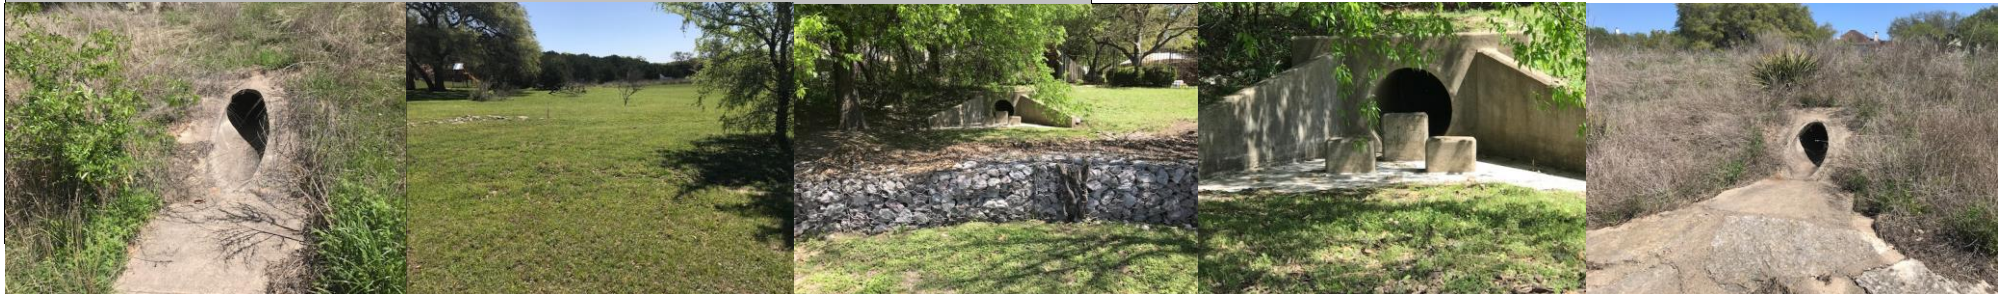
Pond Location	SEC 4
Pond water level	DRY
Does the pond drain within 48 hours?	YES
Sediment depth in the forbay?	N/A
Sediment depth in the sand filter area?	N/A
Trash found at site?	NO
Is vegetation below 18" in height?	NO
Trees or brush found in basin area?	NO
Condition of the media?	GOOD
Condition of vegetation around the out fall pipe	GOOD
Was sediment found in the under drain piping? Remove open clean out tops and check	NO
Any damage to structural elements (pipes, concrete drainage, retaining walls, gabion walls, etc.)?	EROSION ISSUE NEXT TO EMBANKMENT AT GABION - WO 2443736
Discharge valve open operational	N/A
Emergency bypass valve closed and operational	N/A
Are all inlets in area clear of debris and sediment?	YES
	EROSION ISSUE NEXT TO EMBANKMENT AT GABION - WO 2443736
COMMENTS
