Senna Hills Municipal Utility District

Senna Hills Municipal Utility District
General Managers Report for the Month of
April 2021
Board Meeting: May 28th, 2021

Subject: General Manager's Executive Summary Report

SAMCO FINAL LEAK DETECTION REPORT

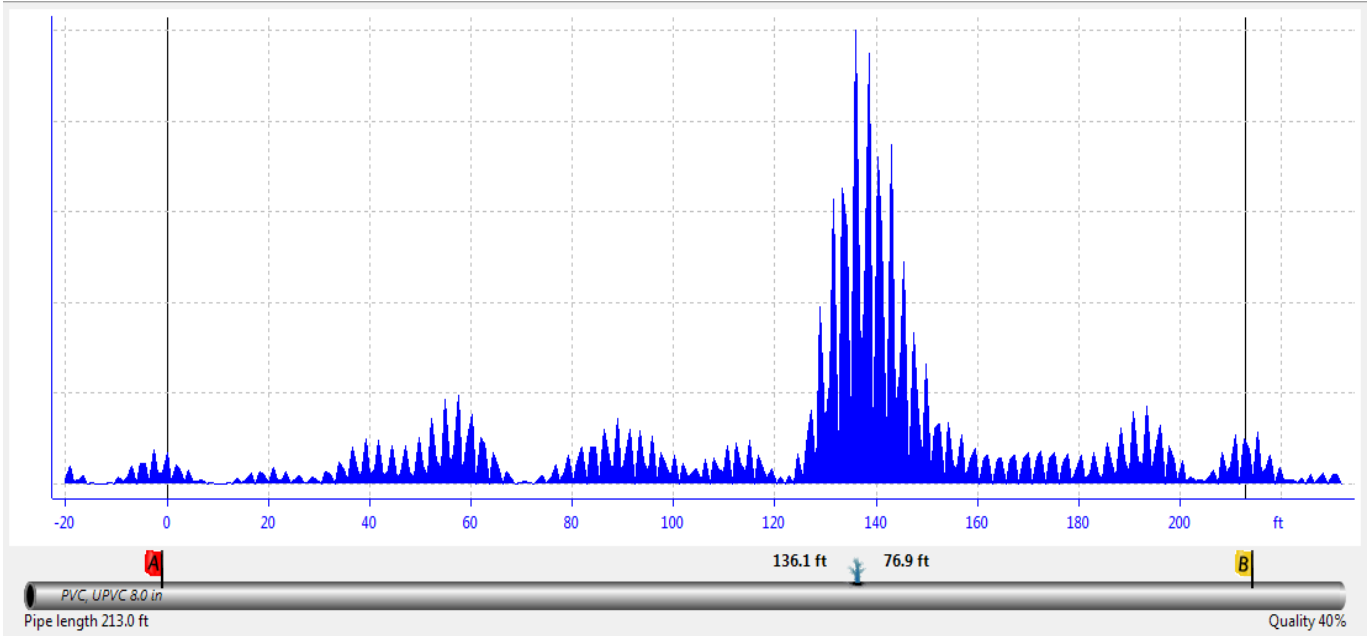
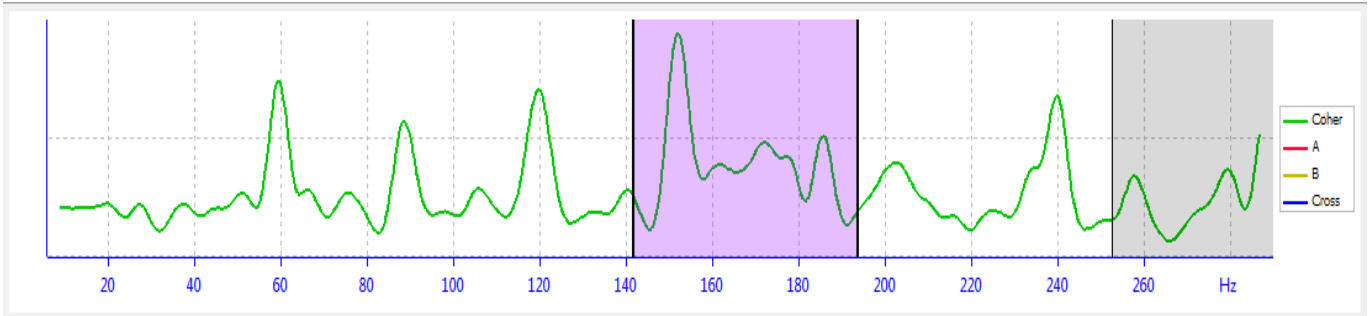
Service Line Leaks			
Leak #	Leak Location	Critical	Date Located
1	10501 Indigo Broom Loop	Yes	05/06/21
2	10309 Indigo Broom Loop	Yes	05/06/21

- Investigate and repair service side leaks
- Investigate and repair meter box leaks
- Investigate, flush, reseal and repair if necessary fire hydrant leaks
- Investigate and recommend customer repair customer side leak
- Continue leak detection to further investigate and reduce water loss
